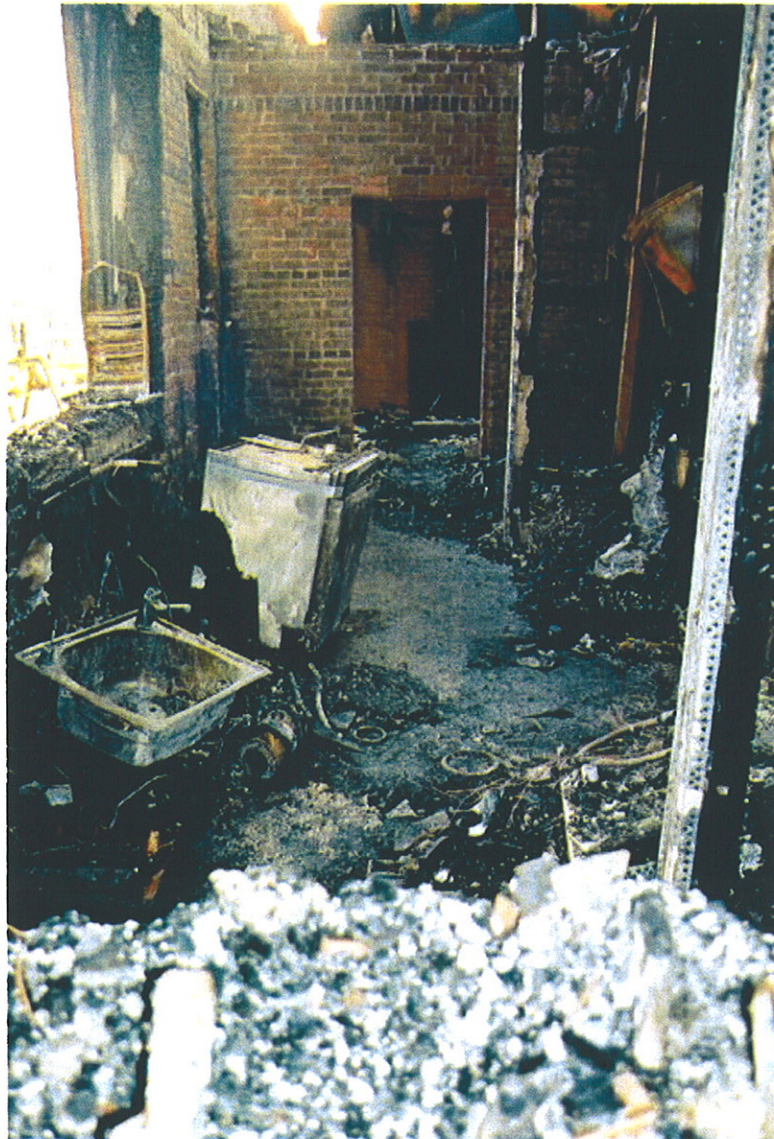
Photo 6: General area of kitchen. Note location of sink, dishwasher and consumption of cabinets and combustible wall space beyond dishwasher.

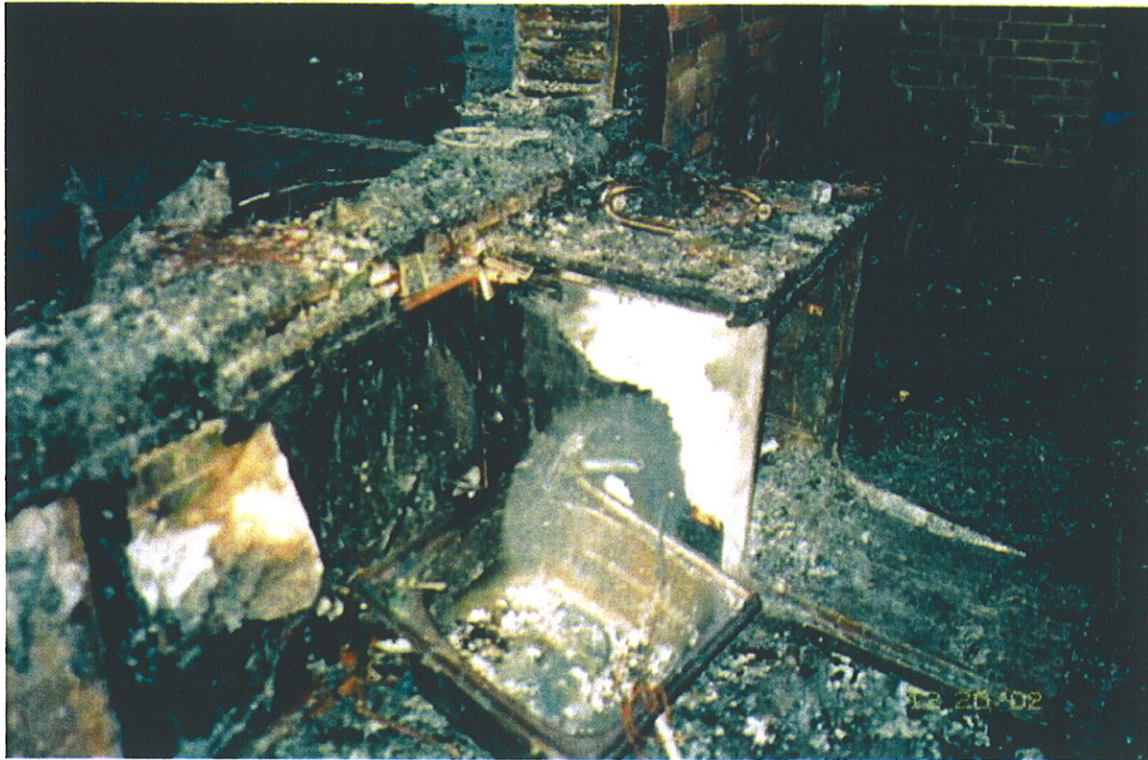
Photo 7: Lt. Fontaine's photo of sink and dishwasher area. Note that the cold water stop is not in place.

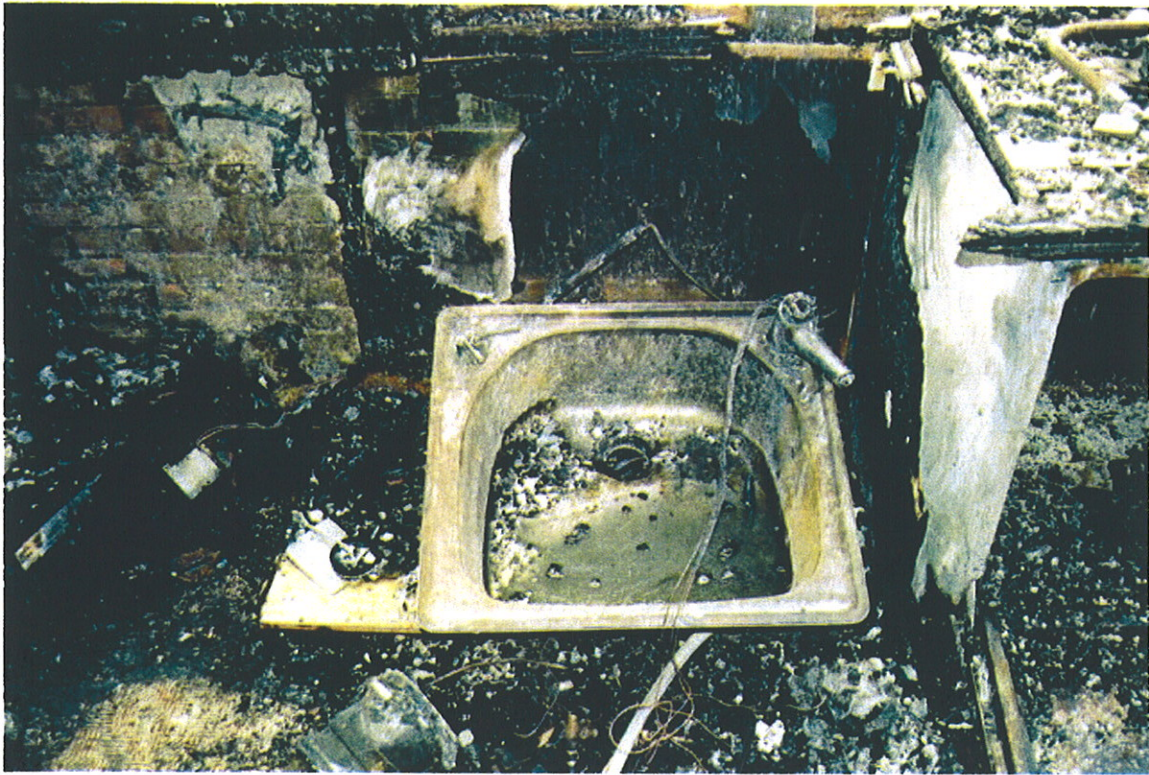
Photo 8: Our first photo documentation of the sink area taken on 12/23/02. Note that the cold water stop is not in place.

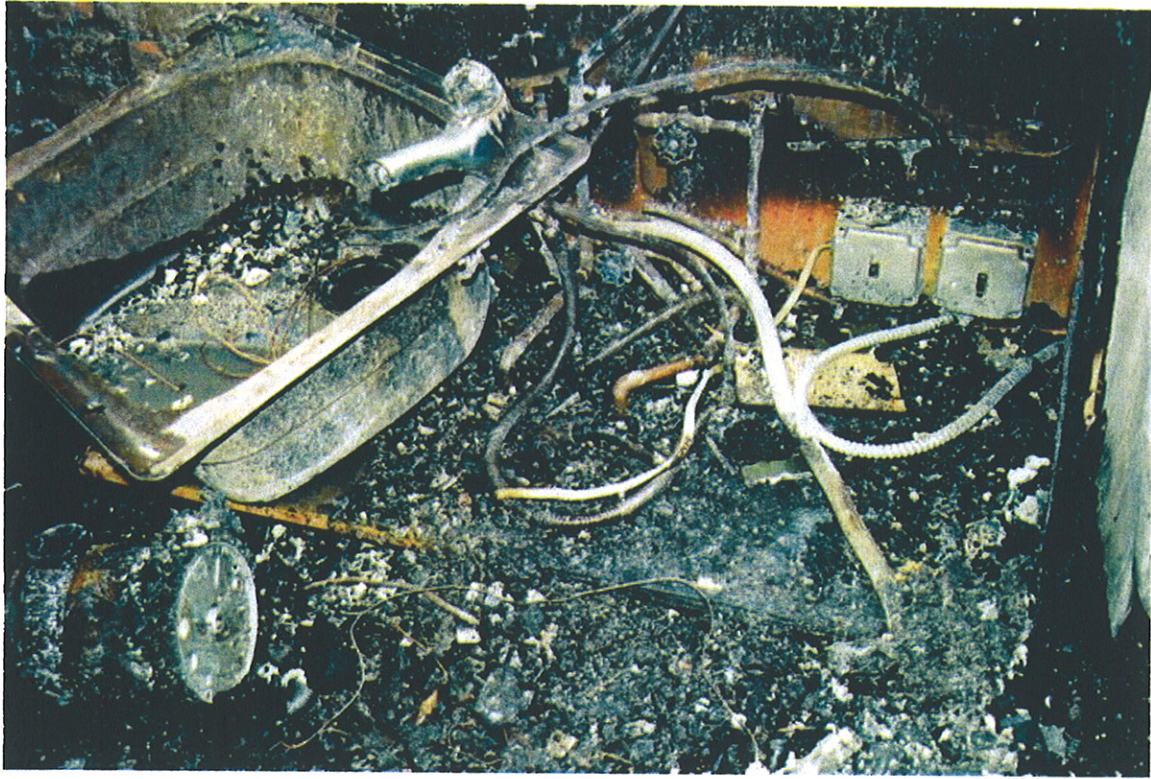
Photo 9: 12/23/02 photo of area beneath the sink. Note that the cold water stop is located on the base of the sink cabinet.

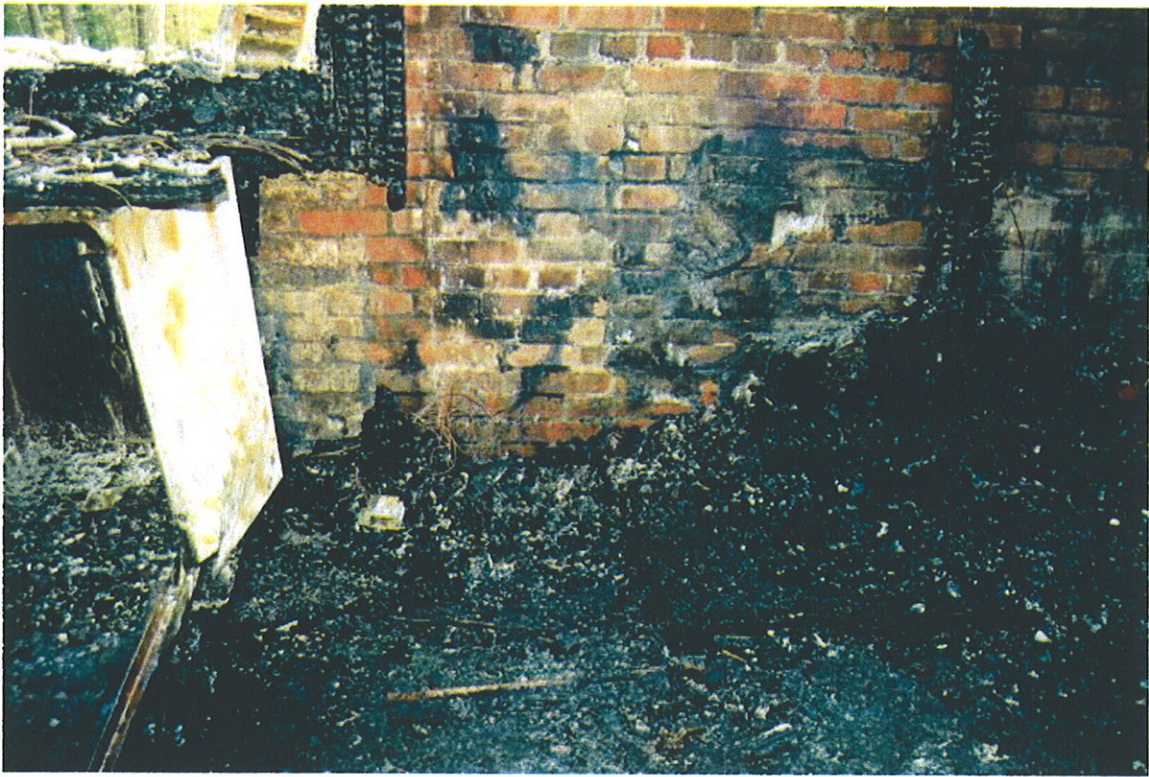
Photo 10: Right hand portion of south wall depicting more complete consumption of combustibles closer to dishwasher; directional fire spread pattern to the right.
